## REPORT SUMMARY

Property: [REDACTED]  
Property Zip / Postal Code: **Willow Grove Pa. 19090**  
Client: [REDACTED]  
Address:

Real Estate Company:  
Real Estate Agent: [REDACTED]  
Inspector: **Bob Klebanoff**  
Inspection Date & Time: **July 7, 2026**

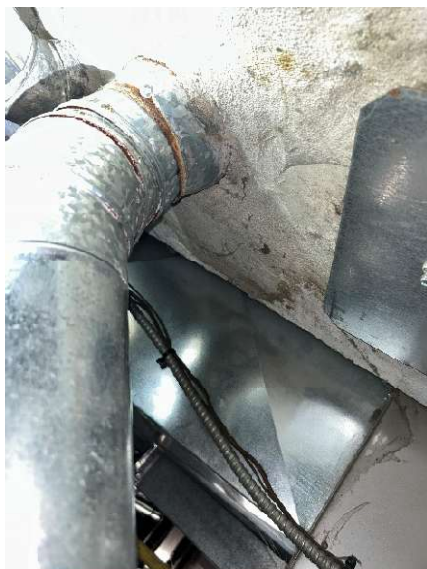
*Corroded chimney seams*

**Corroded chimney seams**

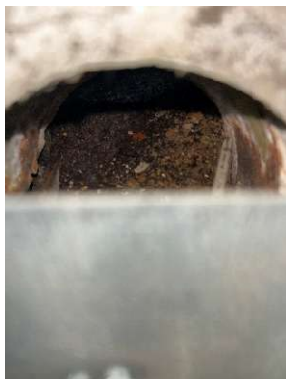
*Corroded debris in the cleanout*

**Corroded debris in the cleanout**

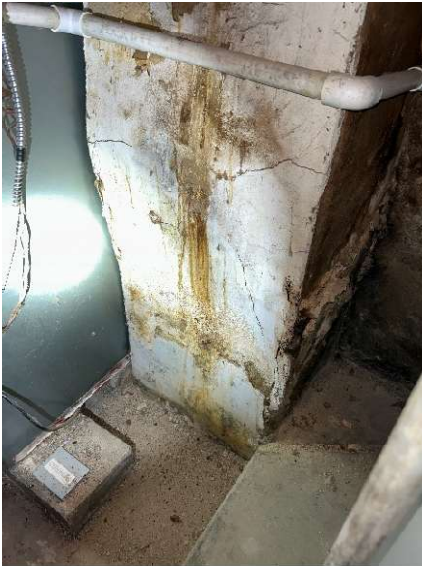
*Damaged chimney base*

**Damaged chimney base**

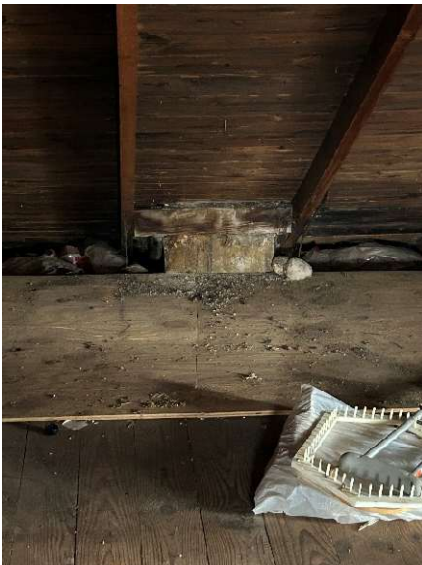
*Masonry around the chimney in the attic*

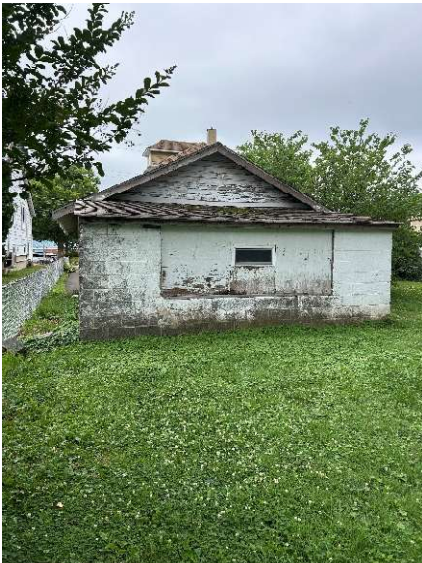
*The garage has not been maintained. Budget for repairs and upgrades*

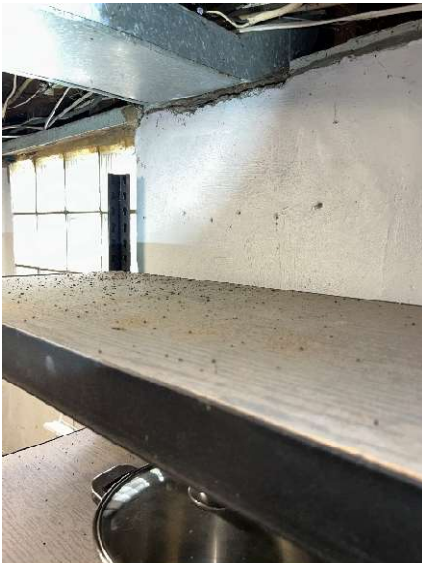
*Mice droppings in the basement and in the electrical panel. Have a qualified contractor further evaluate, exterminate and remove the droppings to reduce the*

risk of a health hazard.

**Mice droppings in the basement and in the electrical panel. Have a qualified contractor further evaluate, exterminate and remove the droppings to reduce the risk of a health hazard.**

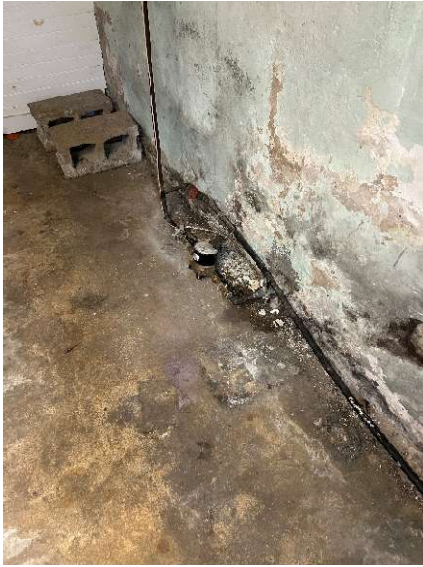
*Discoloration on sections of the basement wall could be mold. See EPA web site for information on mold and contact our office if you would like to schedule testing.*

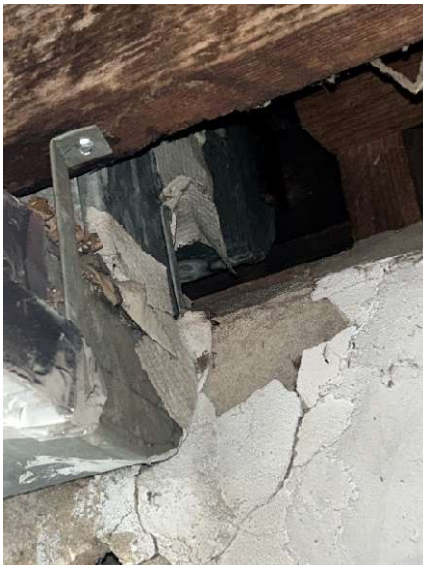
*There appears to be asbestos wrap on sections of the basement ducts. Have a qualified contractor further evaluate and encapsulate and or remove to reduce the risk of a health hazard. (Asbestos is a hazard when it becomes friable and is disturbed)*

**There appears to be asbestos wrap on sections of the basement ducts. Have a qualified contractor further evaluate and encapsulate and or remove to reduce the risk of a health hazard. (Asbestos is a hazard when it becomes friable and is disturbed)**

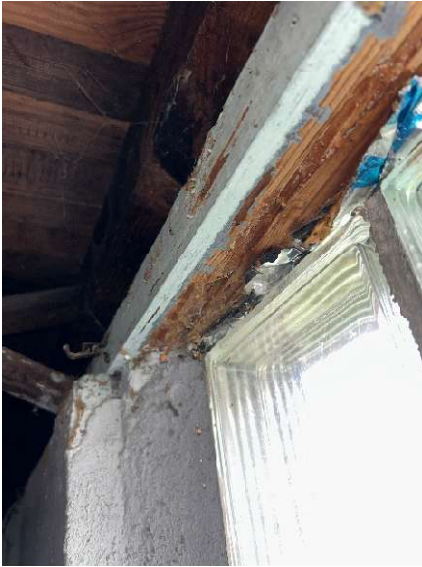
*Evidence of termite shelter tubes in sections of the basement ceiling joists and window lintel. Have a qualified contractor further evaluate, treat and repair to reduce the risk of continued infestation and subsequent damage.*

**Evidence of termite shelter tubes in sections of the basement ceiling joists and window lintel. Have a qualified contractor further evaluate, treat and repair to reduce the risk of continued infestation and subsequent damage.**

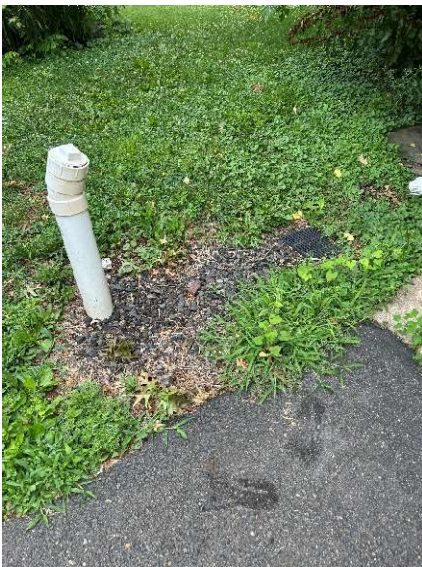
*The waste drains and storm drains have been upgraded. Ask the seller for all documentation.*
