Certificate of  
Mold Analysis

| Property Address | [REDACTED], Kennett Square, PA 19348 |
| Inspection Date | December 16, 2025 |
| Report Number | 1923041 |

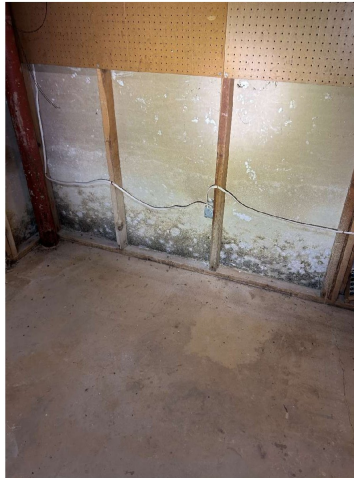
*Photo 1: Basement wall — visible mold growth along base of wall behind removed drywall and pegboard, at floor level between studs*

- **Professional remediation:** Have a qualified mold remediator evaluate and remove the visible mold from the basement walls. The EPA recommends professional remediation for any mold-affected area 3 ft. x 3 ft. or larger.
- **Address moisture source:** Identify and repair the source of water intrusion that caused the visible mold growth. Mold will return if the underlying moisture problem is not resolved.
- **HVAC maintenance:** Replace the HVAC air filter and have ducts professionally cleaned to prevent any future distribution of spores through the air handling system.

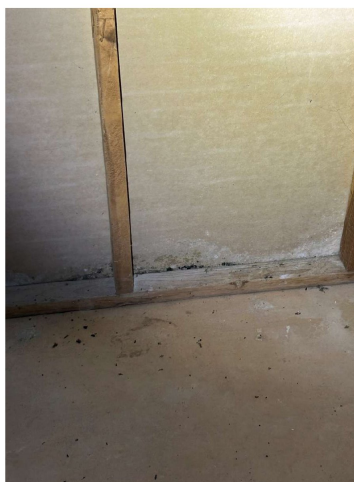
*Photo 2: Close-up — mold growth at base of basement wall behind wall studs, dark discoloration at sill plate area*

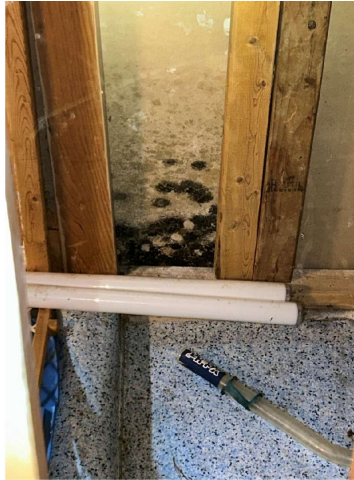
*Photo 3: Mold growth visible behind wall framing near plumbing pipes — dark fungal colonies on drywall backing and framing lumber*
